# **Performance of Tencate Mirafi PGM-G<sup>4</sup> Interlayer-Reinforced Asphalt Pavements in Alaska**

## *Phase I Report*

Submitted to  
Tencate Geosynthetics North America

August 2014

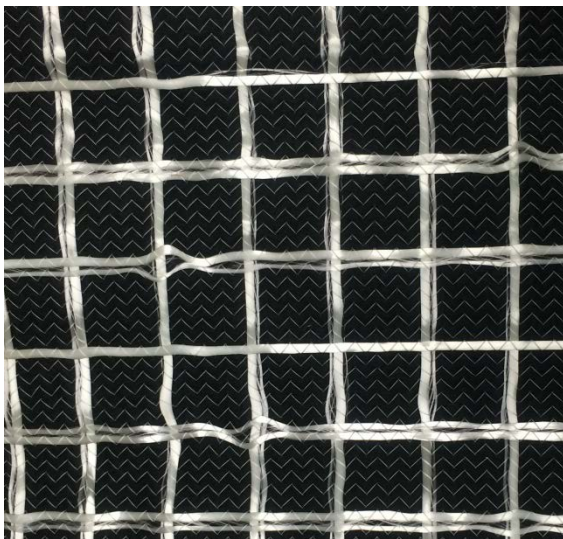
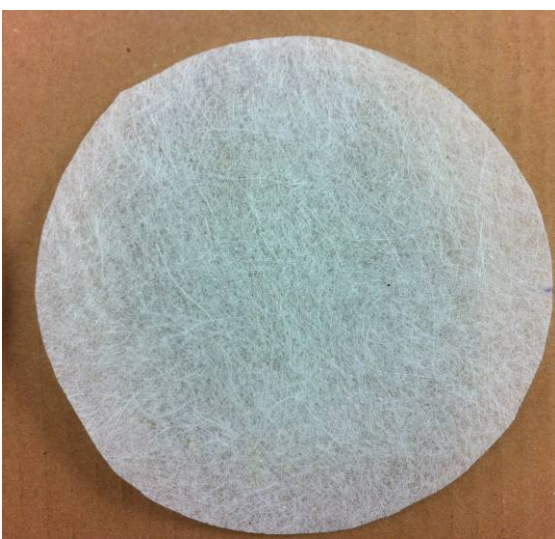
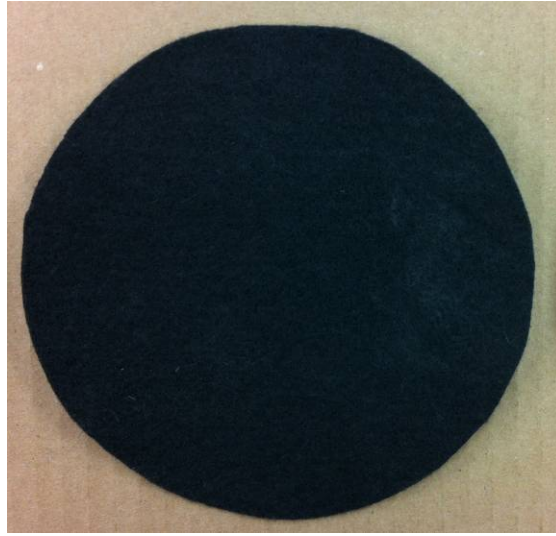
Figure 2.1 Paving interlayers used for specimen fabrication

Five types of interlayers were evaluated in this study and they were PGM-G<sup>4</sup> (multi-axial composite grid), PGM-G100/100 and PGM-G50/50 (bi-axial composite grid), TruPave® (engineered paving fiberglass and polyester hybrid mat), and MPV500 (conventional polypropylene interlayer) (Figure 2.1).

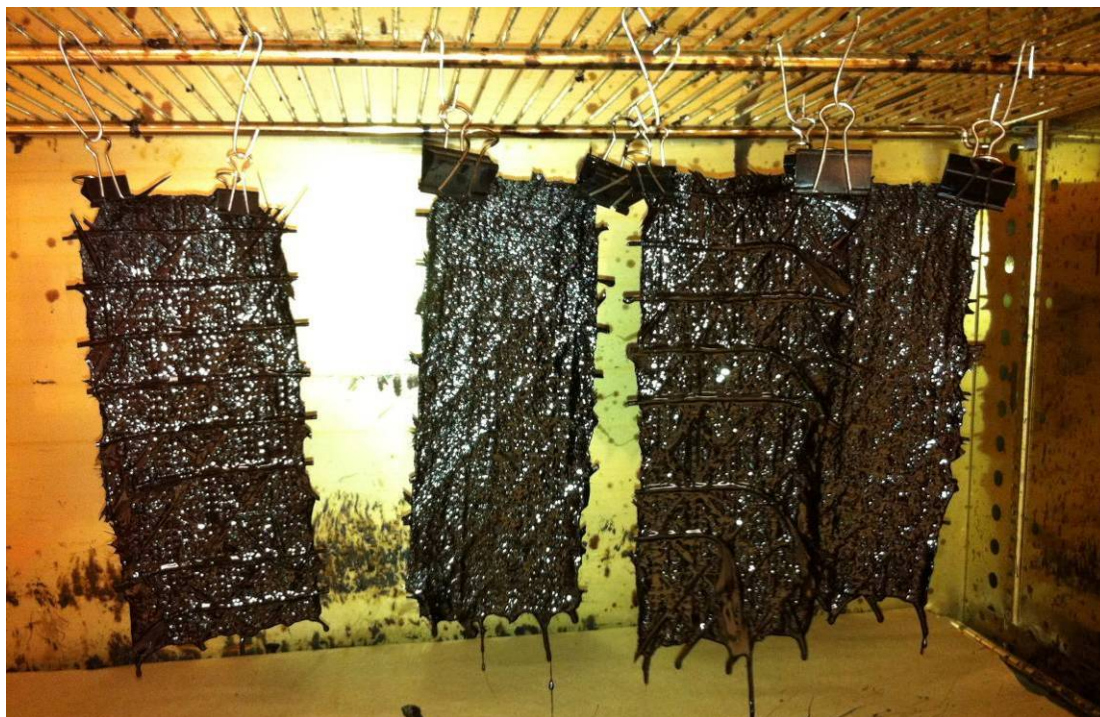
Figure 2.2 Asphalt retention test

Interlayers including PGM-G100/100, PGM-G50/50, TruPave® and MPV500 were cut into the sizes of 4 inches in width and 8 inches in length according to the specified specimen size in ASTM D6140. The width of 4-in approximately covers three grid apertures for PGM-G100/100 and PGM-G50/50, but only covers two and half for G<sup>4</sup>. Therefore, the width of G<sup>4</sup> samples was increased to 4.8 in. Four replicates were made for each type of interlayer. The weight of each specimen was measured and recorded. Specimens were then submerged in the asphalt binder for 30 minutes at 145°C. After required submersion, saturated specimens were hung in the oven at 145°C for 30 minutes and then rotated 180° and hung for additional 30 minutes (Figure 2.2). The weights of saturated specimens were measured and recorded again. The asphalt retention was calculated according to the equation provided in ASTM D6140.

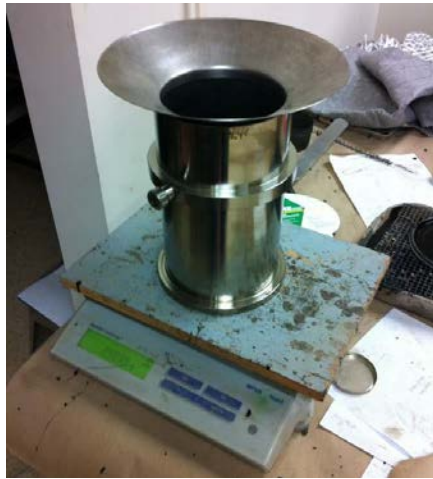
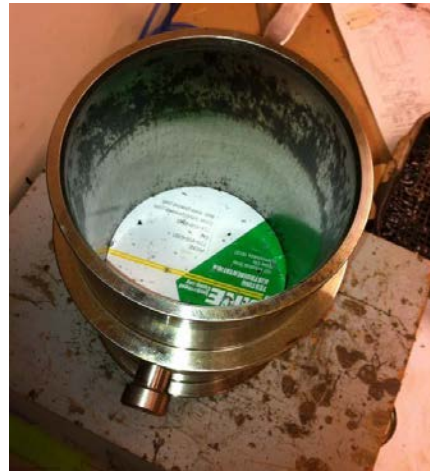
Figure 2.3 Compact first half of specimen

- Step 1: Compact first half specimen as shown in Figure 2.3.
- Step 2: Apply tack coat and place the paving interlayer. The tack coat binder (PG 64-34) was applied on the surface of first half specimen according to the application rates listed in Table 2.4. Then paving interlayer was placed on top of the tack coat binder (Figure 2.4).
- Step 3: the rest of loose mixture was loaded and final compaction was completed (Figure 2.5).

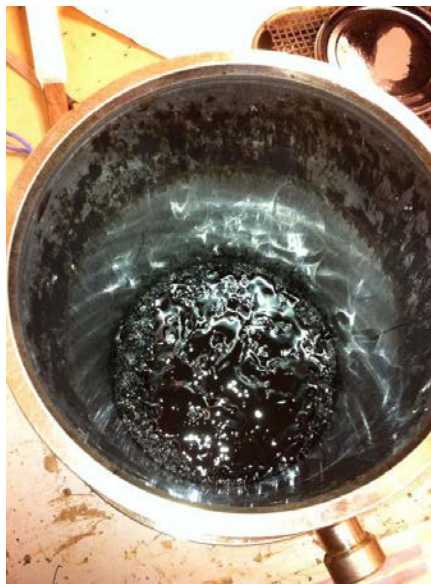
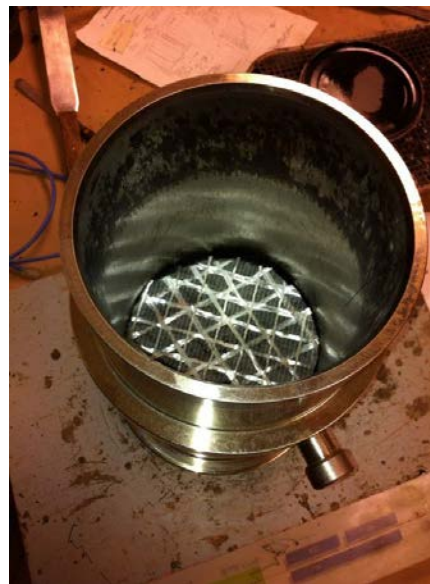
Figure 2.4 Tack coat and paving interlayer

a) Tack coat

b) Paving interlayer

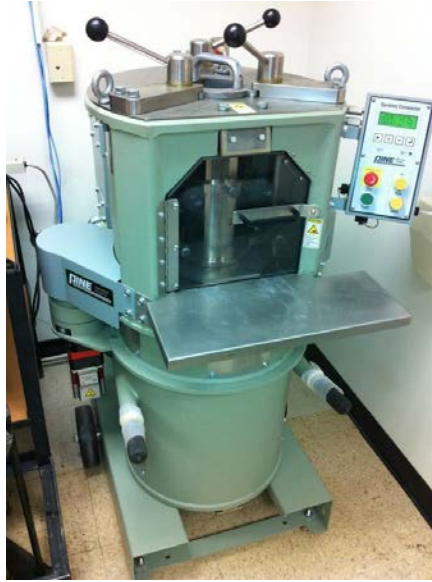
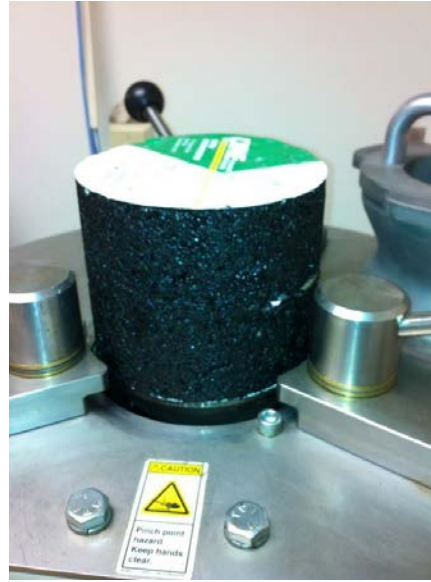
Figure 2.5 Final compaction

a) Final compaction

b) Fresh specimen

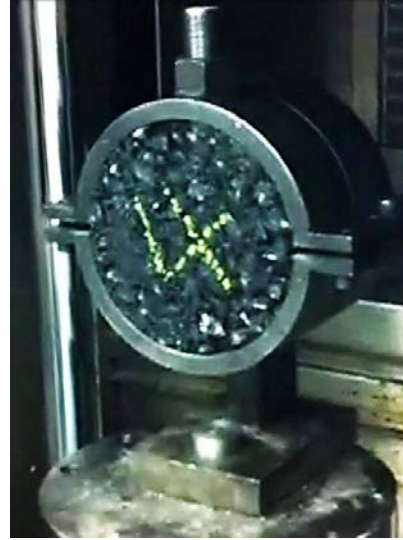
Figure 2.6 Shear testing setup

b) Specimen installation

The shear tests were performed in a computer controlled close-loop hydraulic loading system. The specimen was held in a shear testing fixture as shown in Figure 2.6. During the test, the vertical load was transformed into a shear force through the shear testing fixture. As illustrated in Figure 2.6, the vertical load was applied on the second half of compacted specimens, which simulated the traffic loading condition in the field. The detailed loading conditions are listed in Table 2.3, e.g. for PGM-G<sup>4</sup> treated specimens, when the tack coat was applied to glass side, the load was applied from the nonwoven side. The vertical load was applied on the top part of the specimens at the rate of 12.5 mm/min until specimens were sheared apart.

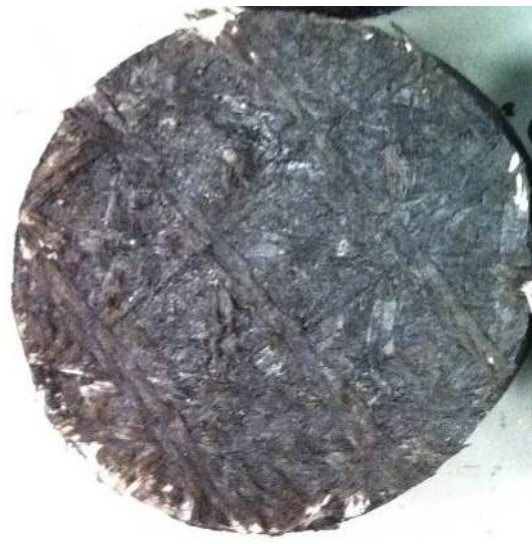
Figure 2.7 Specimens after shear testing

After shear tests, all specimens were sheared off along the glass side of interlayer indicating the interface between glass side and HMA was the weak side (Figure 2.7). Based on such observation, the interlayer needs to be placed with glass side facing down to have a direct contact with tack coat to improve the bonding strength.

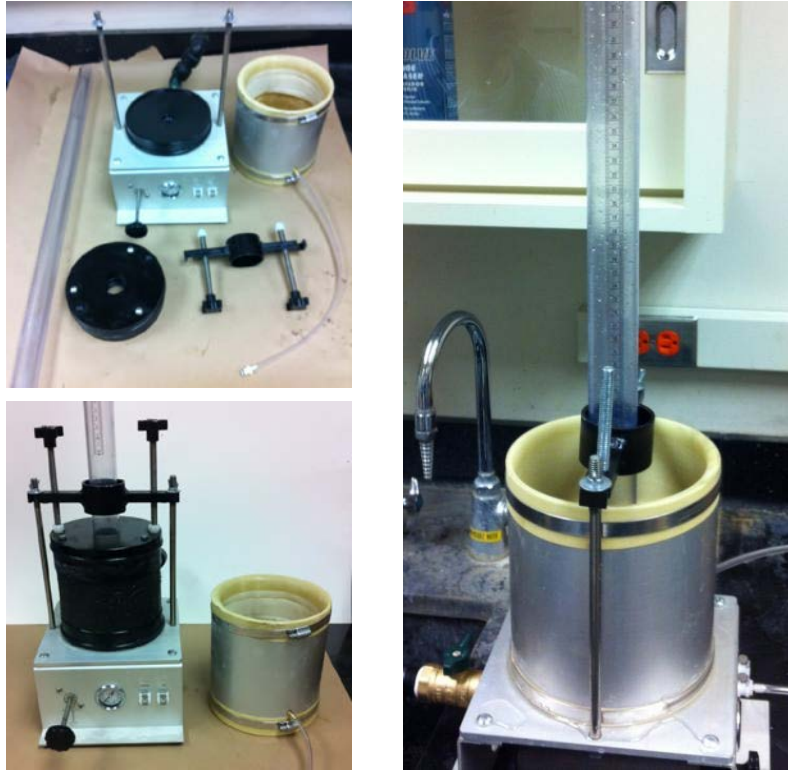
Figure 2.9 Permeameter

Permeability, or coefficient of permeability, is the rate at which a porous material will transmit water under a hydraulic gradient. It is an important property of HMA, which highly correlates to the moisture susceptibility and durability of asphalt pavement. The recommended maximum acceptable permeability is  $125 \times 10^{-5}$  cm/s (Maupin 2000). The permeability tests were performed using a flexible wall permeameter according to ASTM PS 129-01 (2004). The control group was regular HMA without paving interlayer. According to the recommendation from Georgia DOT (2011), the specimens with the height of 75 mm and target air void of 6% were compacted using the same process as the one used for shear test. Figure 2.9 shows the testing setup for the permeability test. Before testing, the specimen was saturated using vacuum. Then, it was taken out and the surface of the specimen was dried using a towel. The petroleum jelly was applied on the side of specimen for sealing to prevent water leaking from the side of the specimen. When the specimen and permeameter was assembled, water was filled into the plastic tube to reach the 500 cm<sup>3</sup> mark (62 cm in height,  $h_1$ ). Then the draining valve was opened. After 30 min, the water head was read and recorded as  $h_2$ . The test was performed twice on the same specimen.

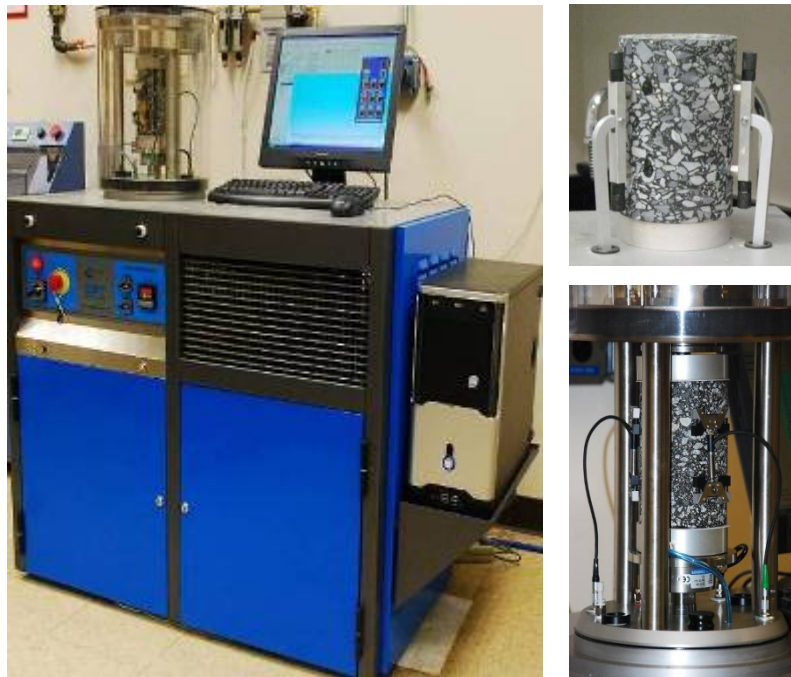
Figure 2.14 Setup of the AMPT

the triaxial cell. The integrated data acquisition and analysis software automatically process measurements and calculated  $|E^*|$  at each loading frequency.

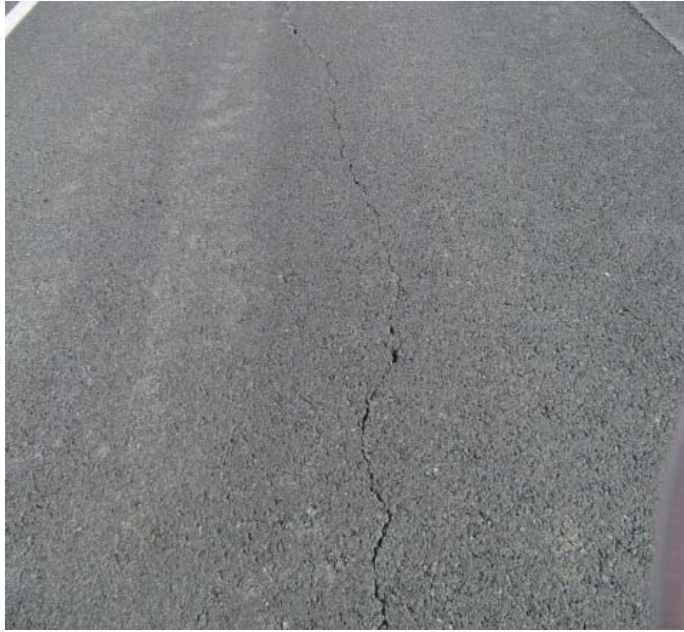
Figure 1 Cracking area 1

ID	Mileage	Location	Length (ft)	Note	Suggestion
1	1.4	Longitudinal, Left lane, in the middle	169		Can be used as a fabric test section. A 6 ft. wide fabric can cover the cracking area.
2	1.6	Longitudinal, mostly in the right lane,	172	Weak foundation	
3	1.7	Longitudinal, right lane,	105	Weak foundation, some on the shoulder	
3a	1.7	Longitudinal, right lane,	158	Weak foundation, some on the shoulder	
4	1.8	Longitudinal, right lane	283		Can be used as a control section
5	1.9	Longitudinal, right land	191	On the shoulder	Not suggested as a test section, since it is on the shoulder.
6	2.1	Longitudinal, left lane	142		Can be used as a fabric test section, which needs a 12 ft. wide fabric.
7	3.5	Longitudinal, left lane	386	most of the crack is on the longitudinal joint	
8	3.6	Longitudinal, left lane	247	including one transverse cracking	Can be used as a fabric test section. It needs a 12 ft. wide fabric.

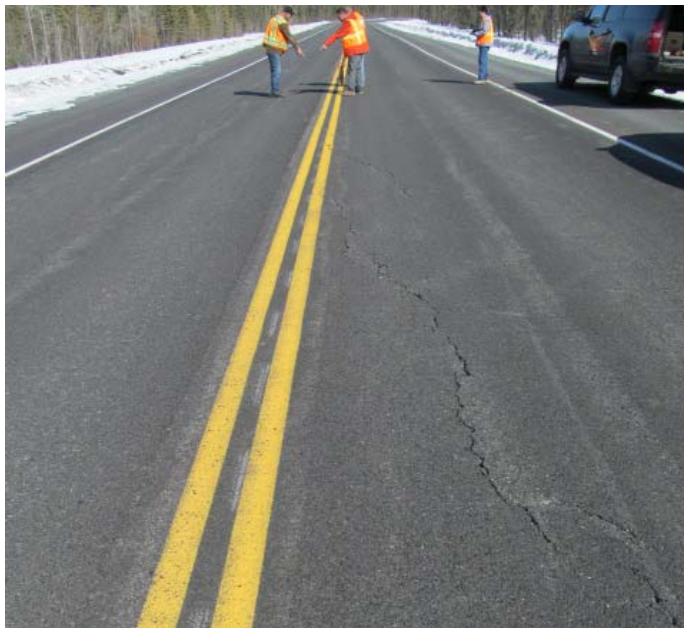
Figure 2 Cracking area 2

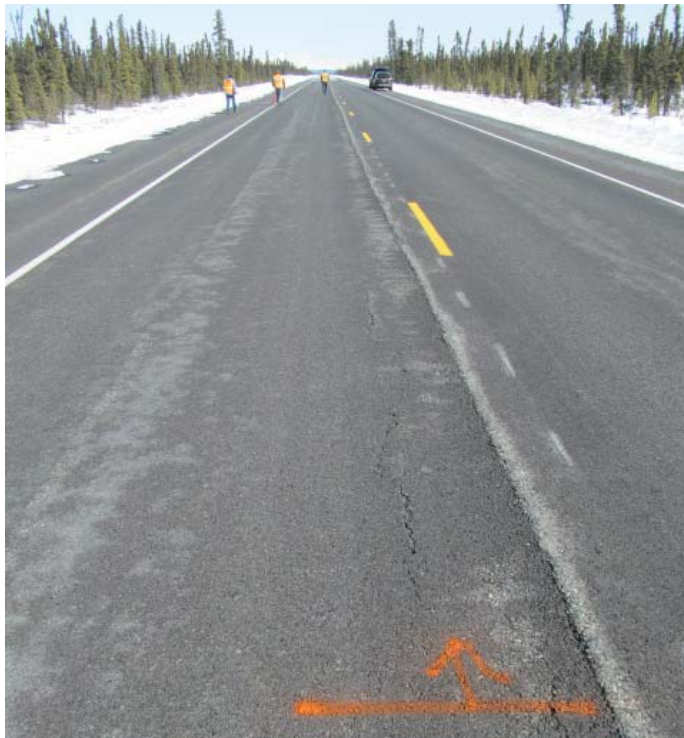
Figure 10 Cracking area 9

9	3.8	Longitudinal, left lane	245		Can be used as a fabric test section. It needs a 6 ft. wide fabric.
10	4.1	Longitudinal, left lane	478		Can be used as a control section and a fabric test section next to each other for comparison. It needs a 12 ft. wide fabric.
11	4.8	Longitudinal, right lane	293	on the shoulder	Not suggested as a test section, since it is on the shoulder.
12	6.7	Longitudinal, left lane close to joint	157

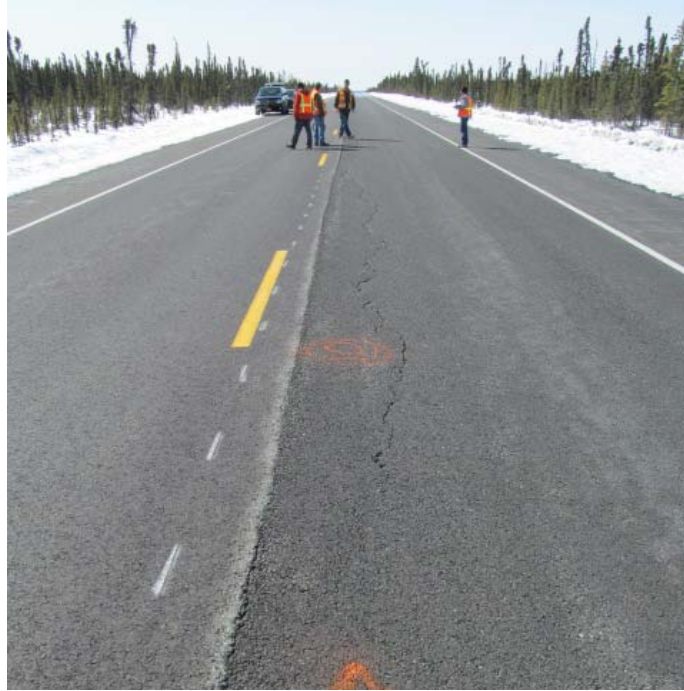
Figure 11 Cracking area 10

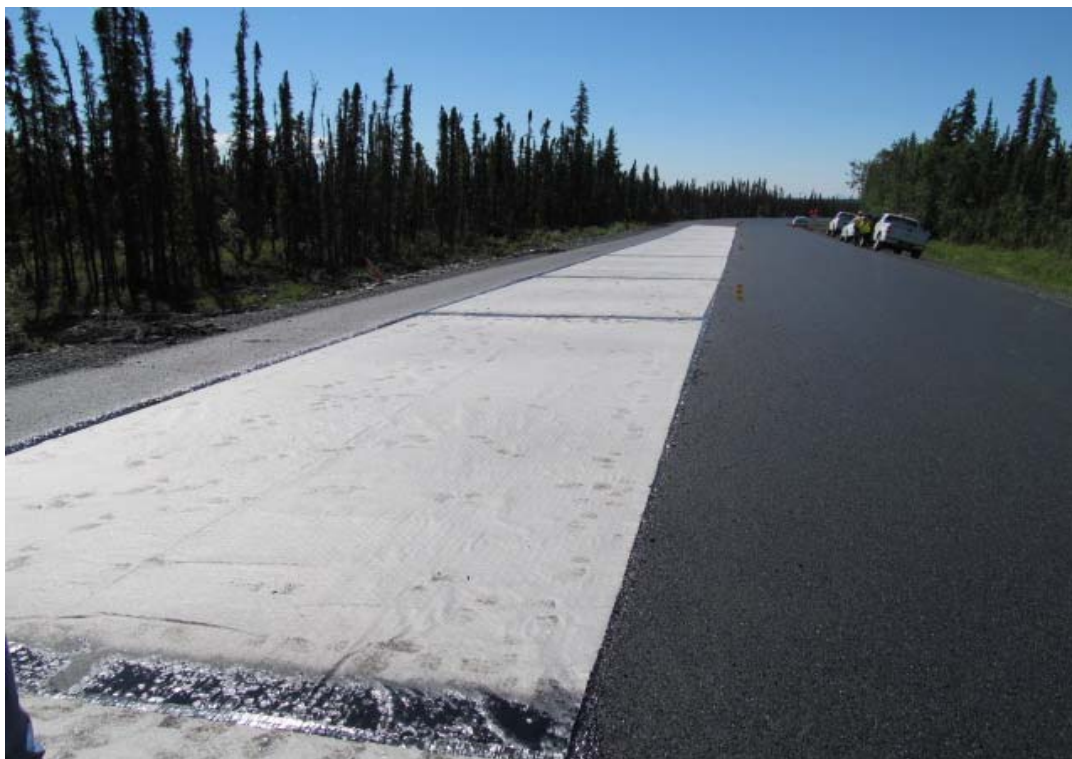
Figure 14  $G^4$  test section

Three test sections reinforced with paving interlayers were established in July, 2013: one with  $G^4$  in areas 2 and 3 (Figure 14), one with G50/50 in area 9 (Figure 15), and one with G100/100 in area 10 (Figure 16). A tack coat of neat oil was applied at the shooting rates of  $0.19 \text{ gal/yd}^2$ ,  $0.27 \text{ gal/yd}^2$ , and  $0.27 \text{ gal/yd}^2$  for sections with  $G^4$ , G50/50 and, G100/100 respectively. Area 4 was selected as the control section without paving interlayers.

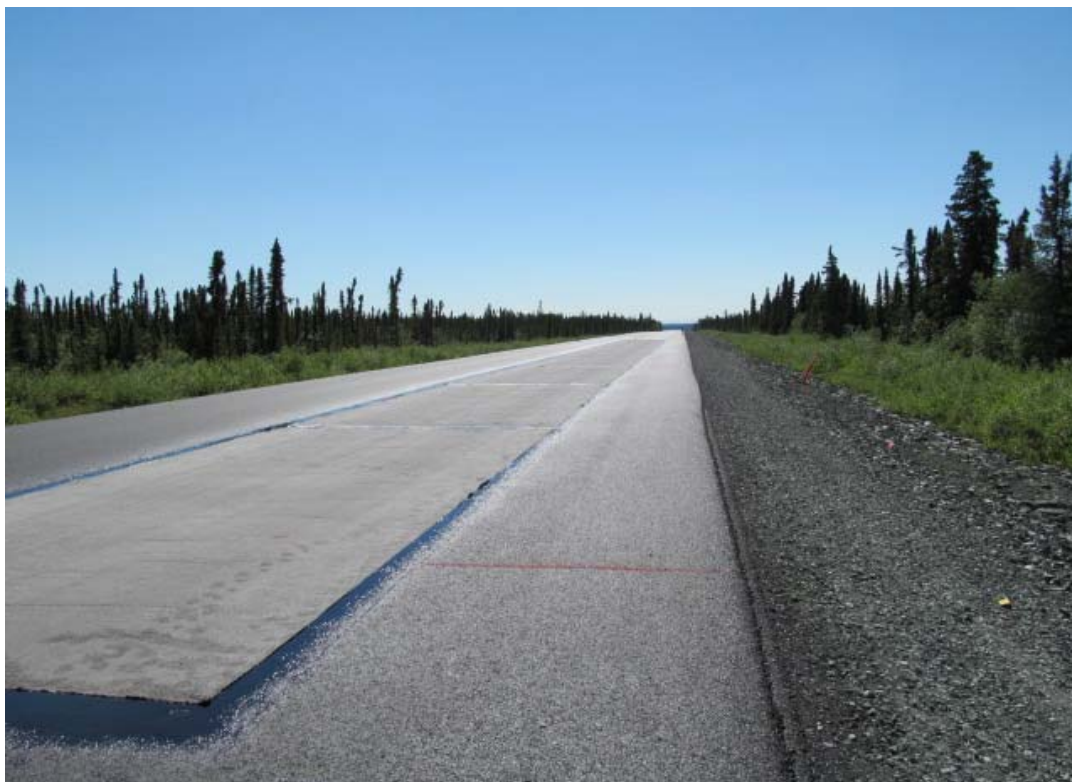
Figure 15 G50/50 test section

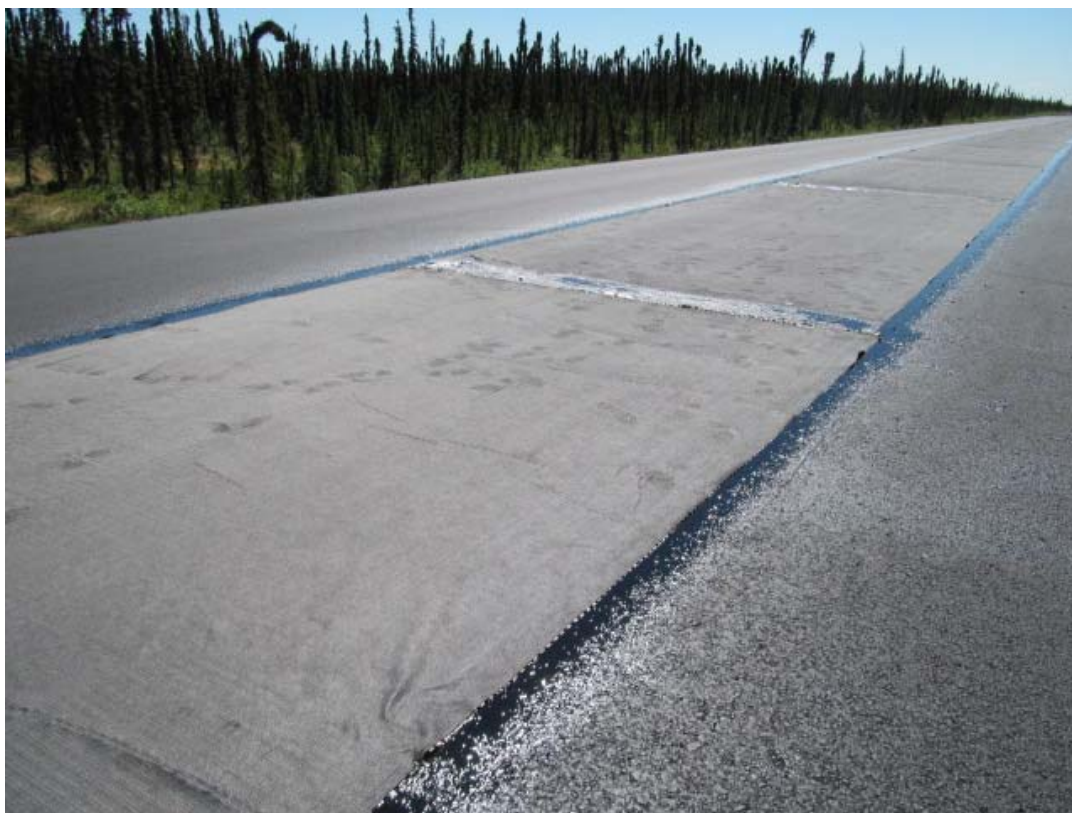
Figure 16 G100/100 test section

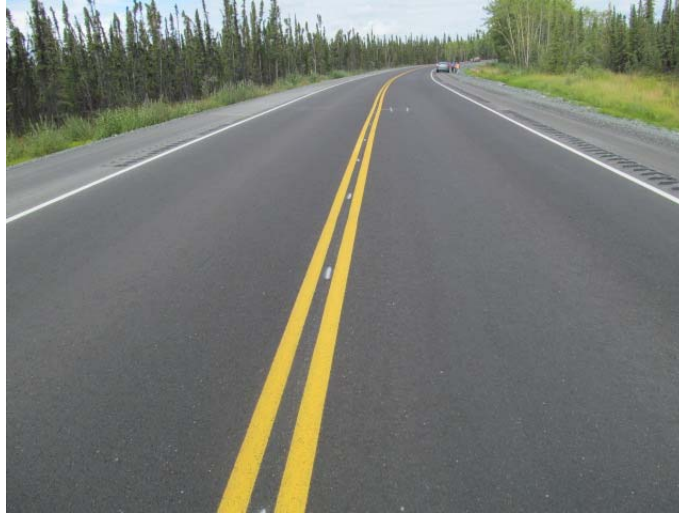
Figure 17 Control section (300 feet in area 4)

Two pavement condition surveys were conducted on August 19 and October 12, 2013. No cracks were found in any of the test sections during these two field trips (Figures 17-20).

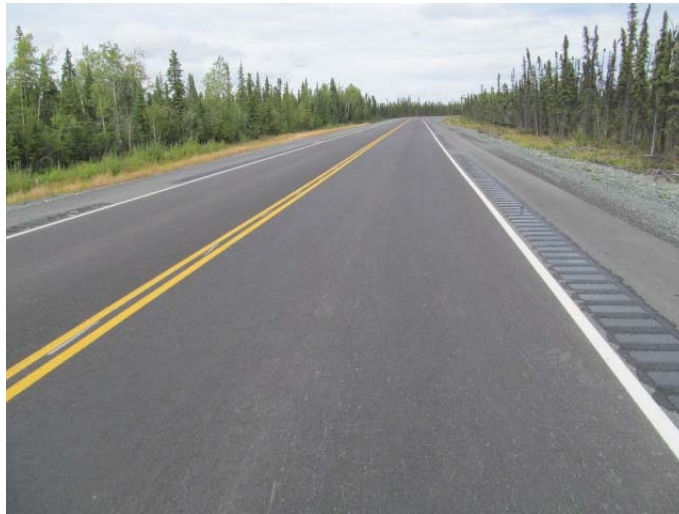
Figure 18  $G^4$  test section (reinforced with 300 feet of  $G^4$  paving interlayer in the right lane in area 2, no visible cracks)

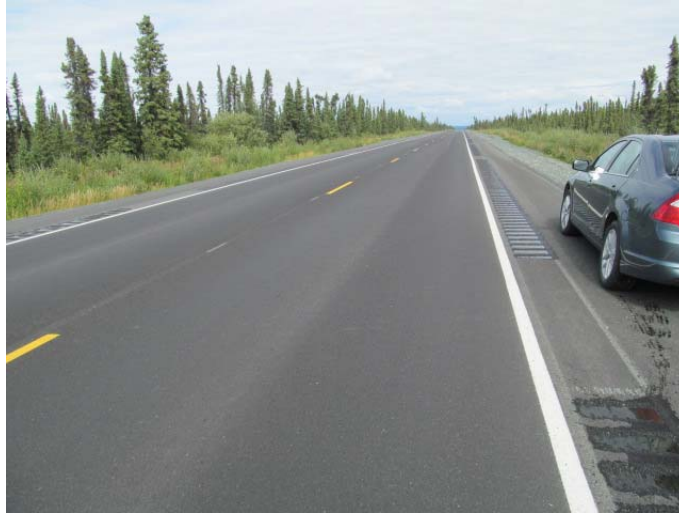
Figure 19 G50/50 test section (reinforced with 300 feet of G50/50 in the left lane in area 9, no visible cracks)

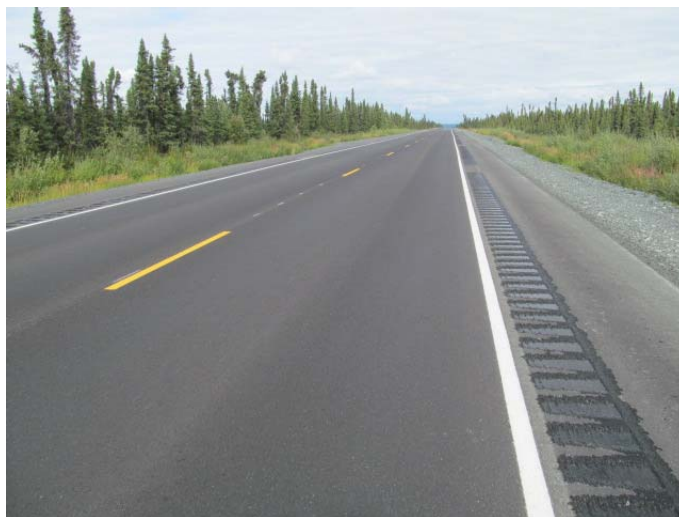
Figure 20 G100/100 test section (reinforced with 300 feet G100/100 in the left lane in area 10, no visible cracks present)

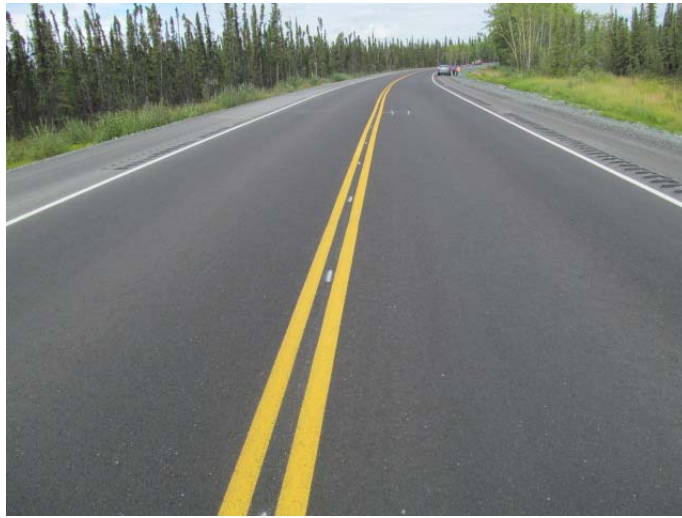
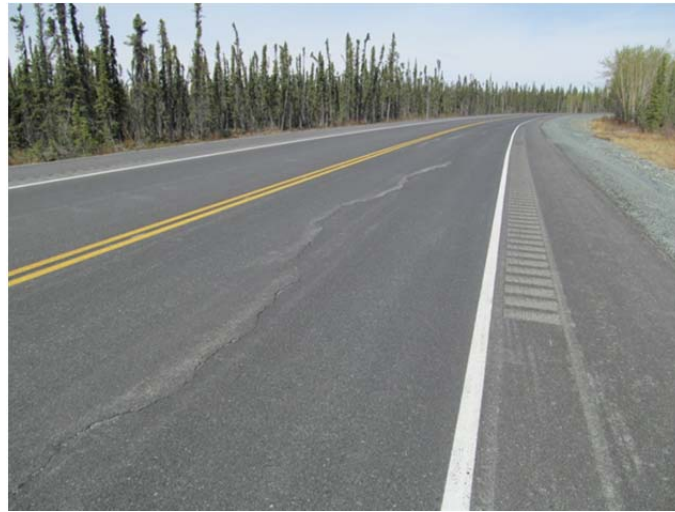
Figure 21 Control section: a) no visible cracks (October 12, 2013); b) 266 feet of longitudinal cracking (May 15, 2014)

Section	Transverse crack (#)	Longitudinal crack, NB (ft)	Longitudinal crack, SB (ft)
Control (area 4)	0	266 medium-major	0
G <sup>4</sup> (areas 2 & 3)	3 minor	17 minor	0
G50/50 (area 9)	1	-	36 minor
G100/100 (area 10)	1	-	0

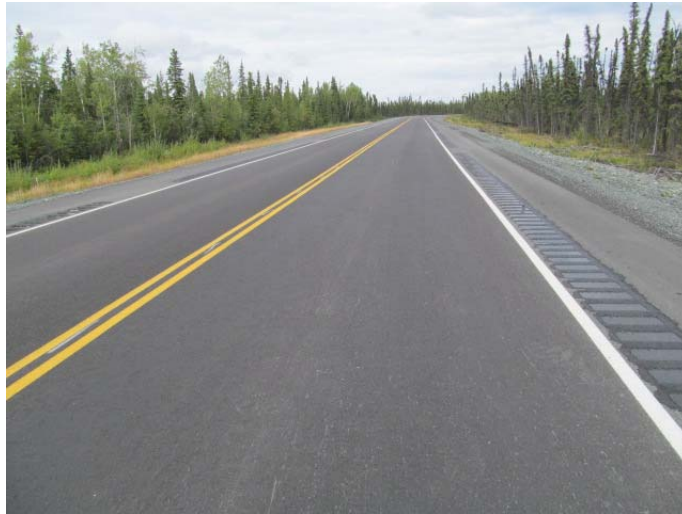
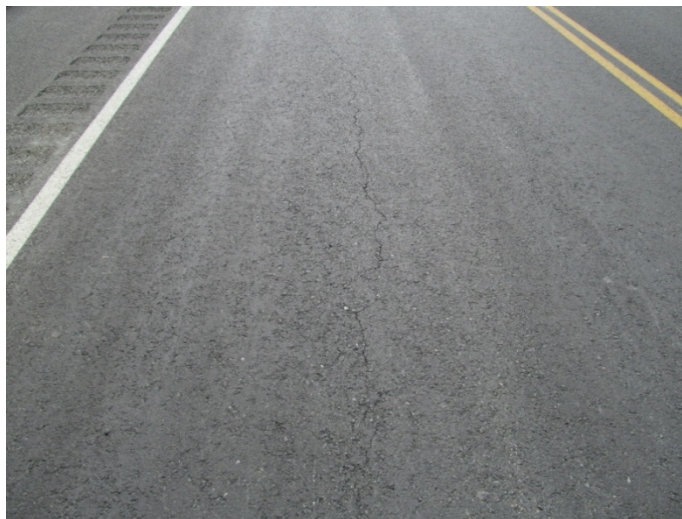
Figure 22  $G^4$  test section: a) no visible cracks (October 12, 2013); b) both longitudinal and transverse cracks present (May 15, 2014)

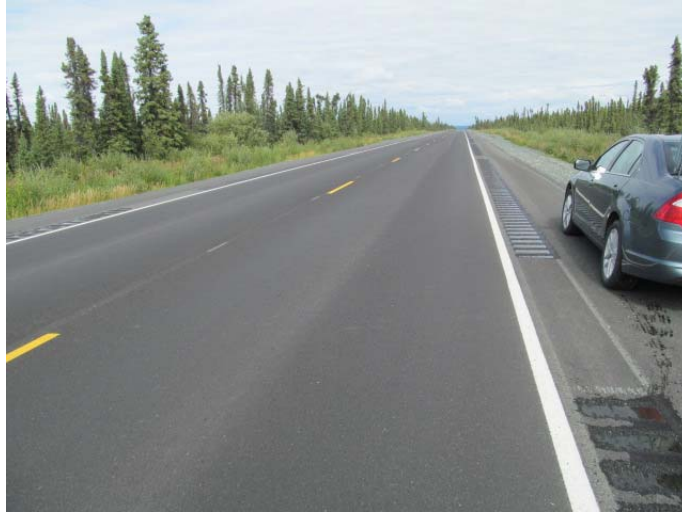
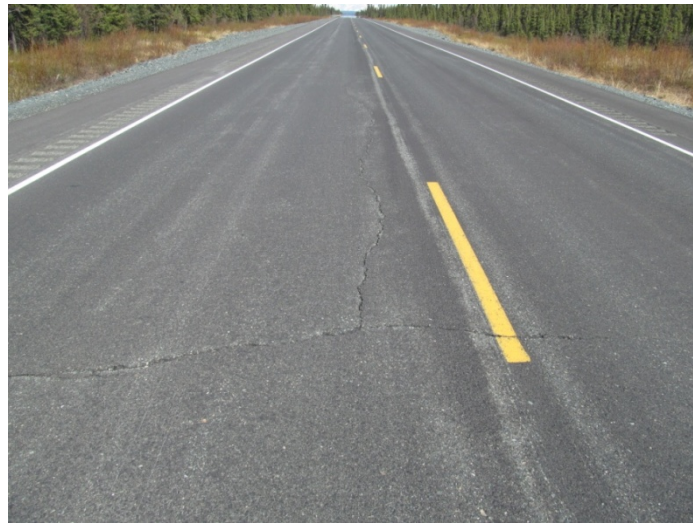
Figure 23 G50/50 test section: a) no visible cracks (October 12, 2013); b) both transverse and longitudinal cracking present (May 15, 2014)

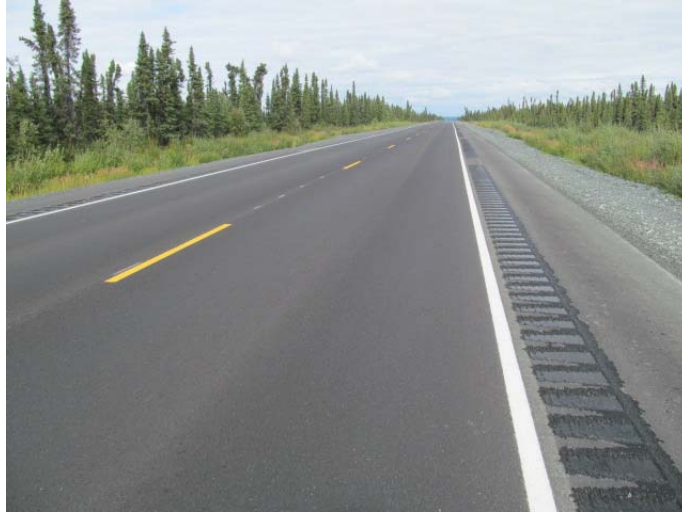
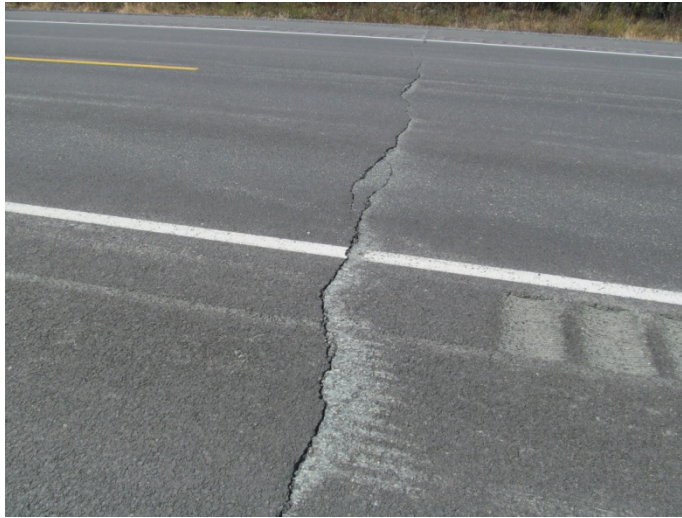
Figure 24 G100/100 test section: a) no visible cracks (October 12, 2013); b) transverse cracking present (May 15, 2014)

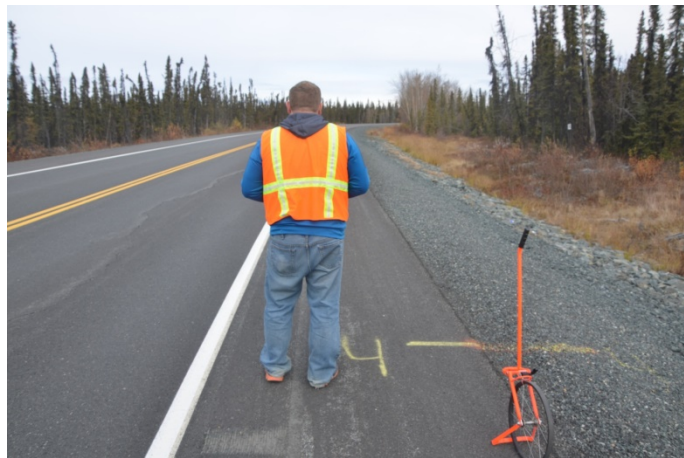
Figure 25 Control section (area 4) no new cracking

The G<sup>4</sup> reinforced section (area 2) had the only new crack found in all of the test sections and it was minor (Figure 25-27). There were many very small fissures where it was likely that after the next winter more cracks would become pronounced. Overall the test sections including the controls were in the same condition as the last evaluation.

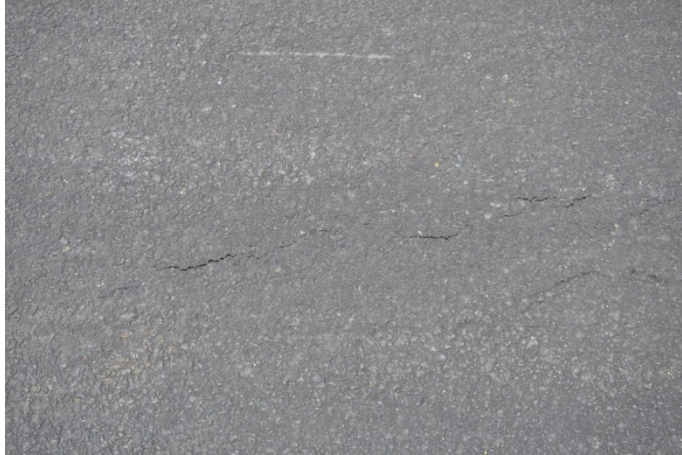
Figure 26 G<sup>4</sup> section (area 2) new minor cracking

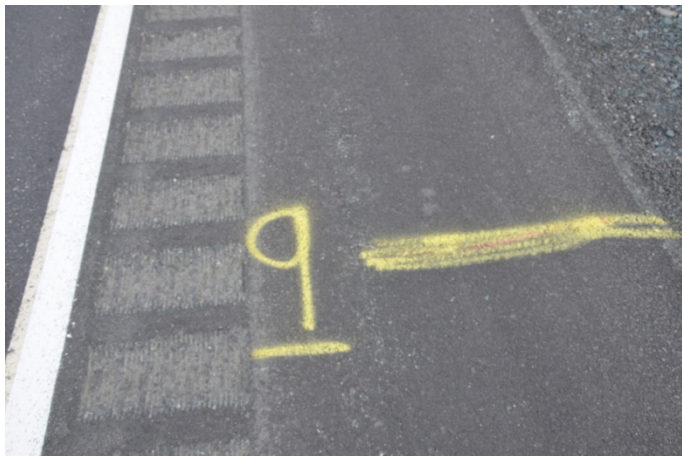
Figure 27 G50/50 and G100/100 (sections 9 and 10) no new cracking

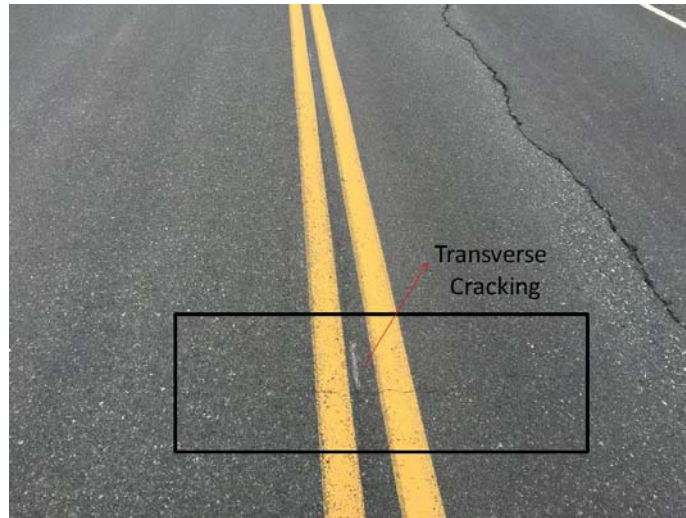
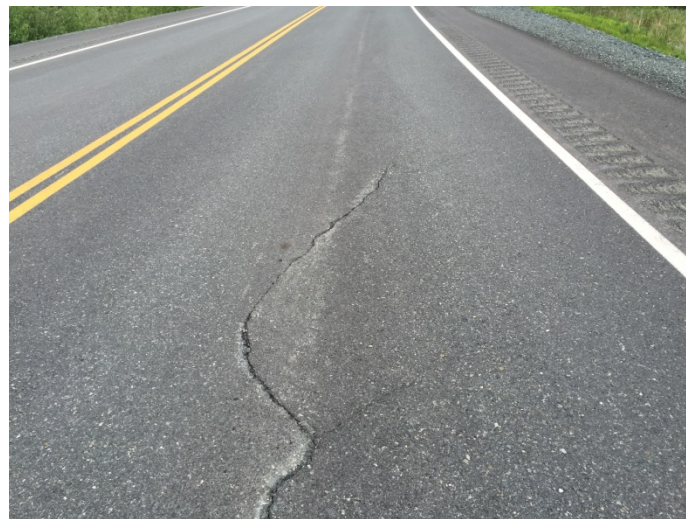
Figure 28 Control section: a) new minor transverse cracking; b) new moderate-major longitudinal cracking

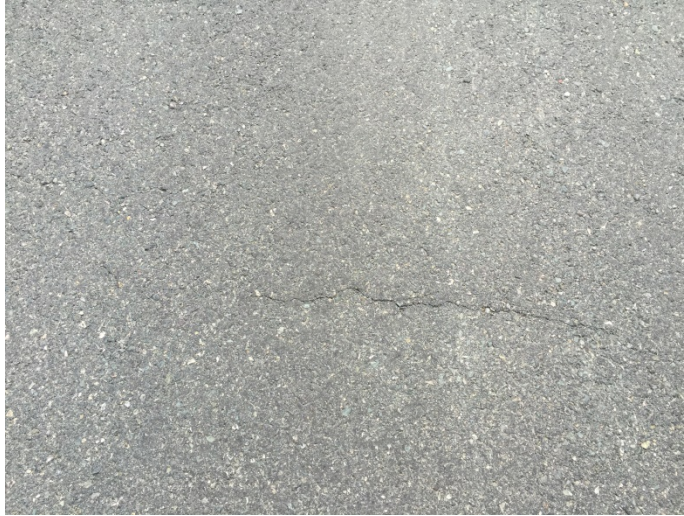
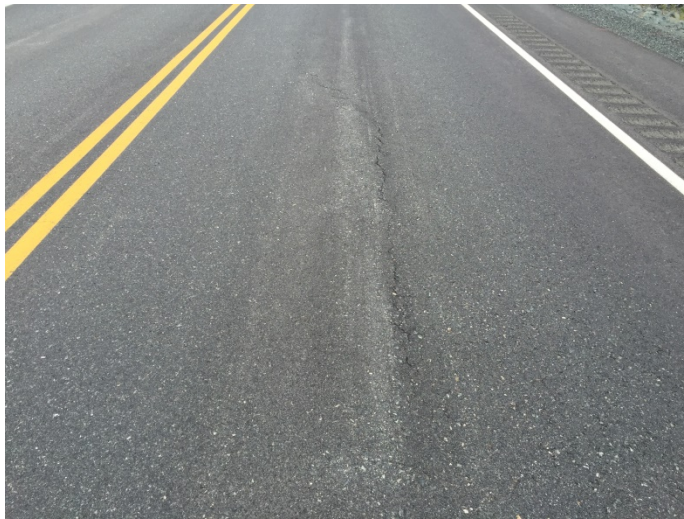
Figure 29  $G^4$  test section: a) new minor transverse cracking; b) new minor longitudinal cracking

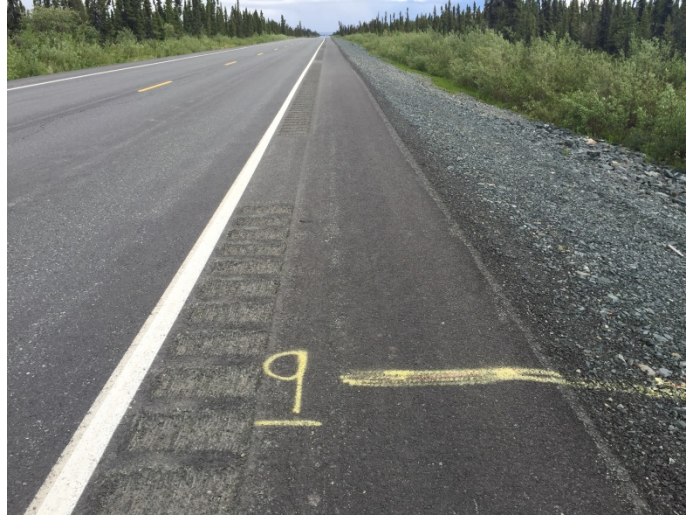
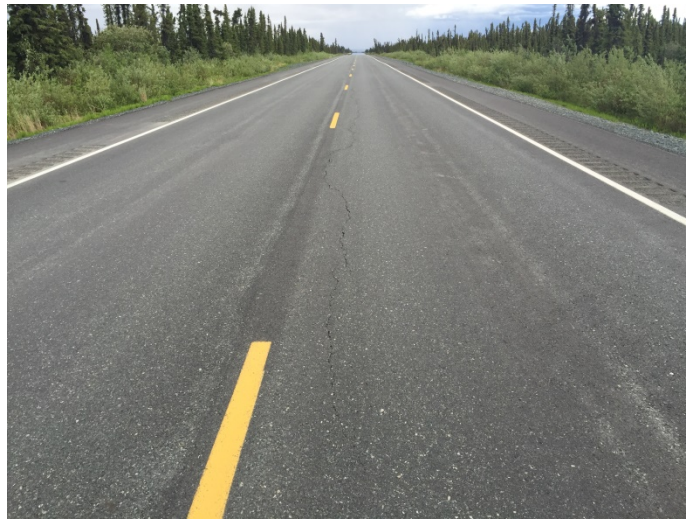
Figure 30 G50/50 test section: a) no new transverse cracking; b) new minor longitudinal cracking

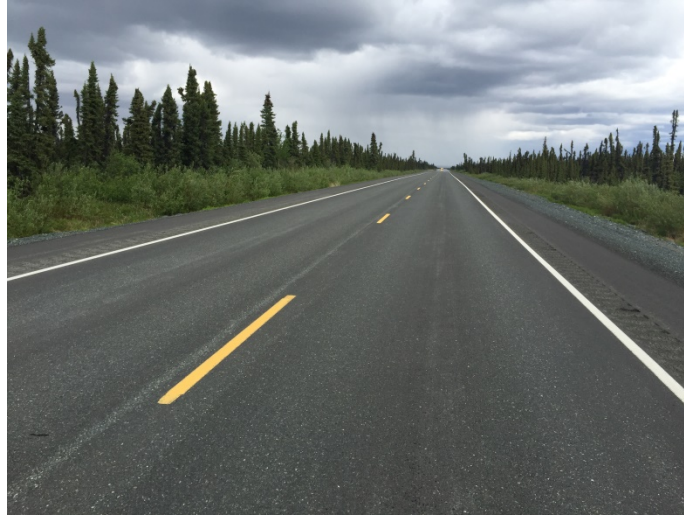
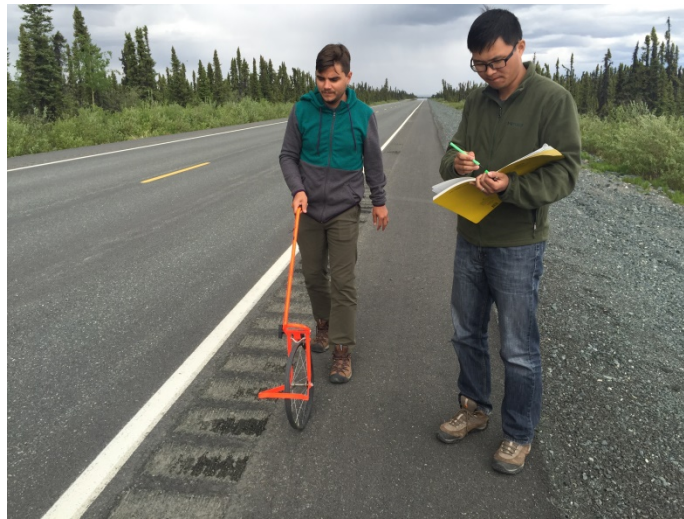
Figure 31 G100/100 test section: a) no new transverse cracking; b) no new longitudinal cracking
